# Manhole Inspection Summary

Manhole # S31GG\_052MH

Insp Date: **1/19/07 9:35 AM**

**Location** Address: **145 LANVALE ST**

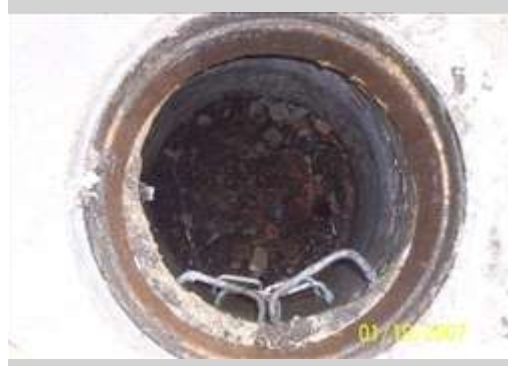
Top View

Channel debris.

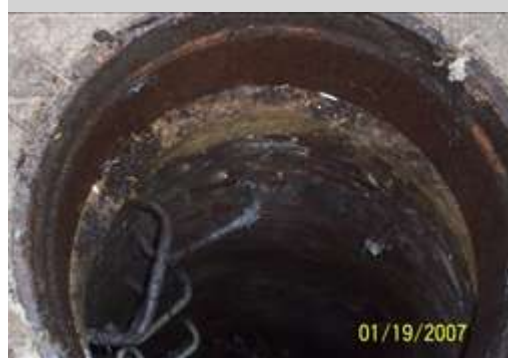
Defect

Frame leaks. Frame offset. Adjustment and Barrel infiltration.

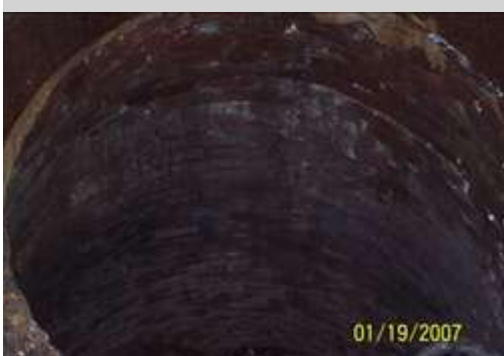
Defect

Adjustment, Corbel, and Barrel infiltration.

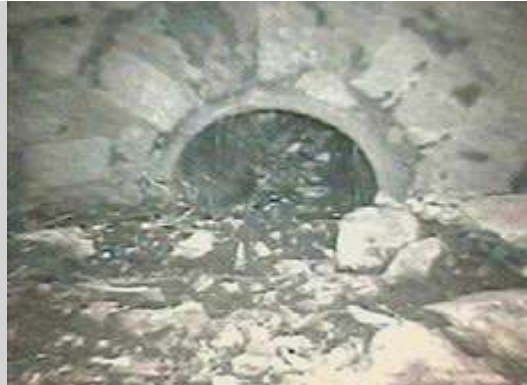
### 8 in. Circular Gravity Sewer Pipe Out @ 12 O'Clock

Deposits: ☐ None ☒ **Mud** ☐ Sludge ☒ **Debris** ☐ Grease

Silt Depth: **2** (in.) Deposits Extent: **Medium**

Infiltration: **Evidence** Pipe Seal Cond: **Unknown**

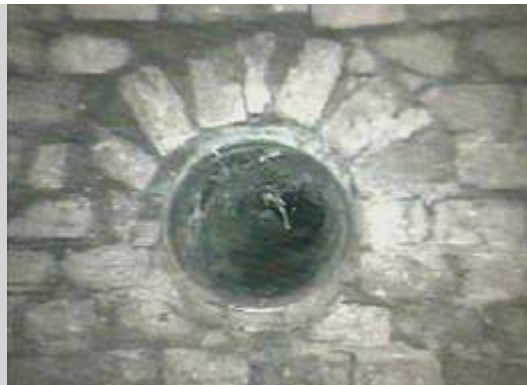
### 8 in. Circular Gravity Sewer Pipe Out @ 9 O'Clock

Infiltration: **Evidence** Pipe Seal Cond: **Unknown**
